Beeping Tones Associated with “Out-of-Range” Shock Lead Impedance

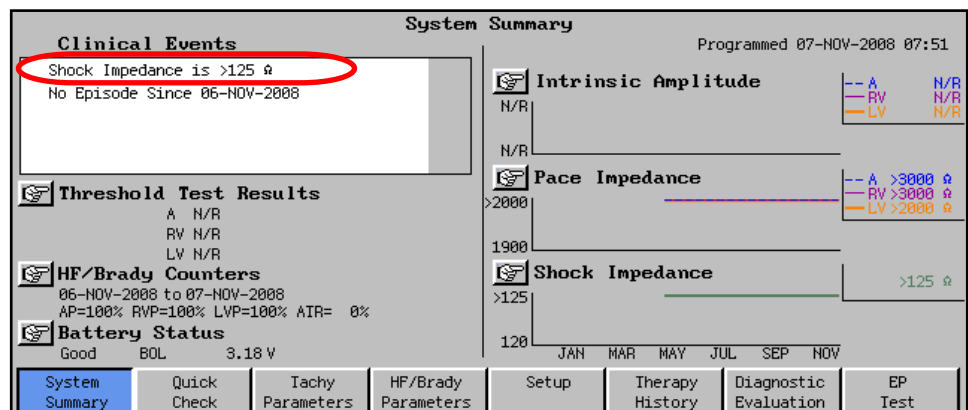
Upon the first programmer interrogation following detection of an out-of-range shock lead impedance value, a message will display in the Clinical Events window of the System Summary screen (Figure 1). Additionally, for those devices enrolled in LATITUDE Patient Management System, an out-of-range value also triggers a red alert.¹

Figure 1. System Summary screen displaying shock lead impedance outside the normal range.

Any time an out-of-range shock lead impedance condition is reported, clinicians should conduct standard lead testing and troubleshooting procedures to identify root cause and resolve the issue. For assistance with any out-of-range messages, please contact a local Boston Scientific CRM representative or CRM Technical Services.
